## Malagiri Dhara:

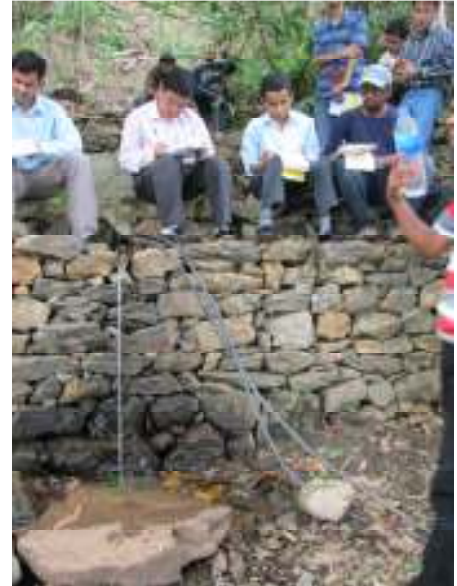
The rock in the area is phyllite, but no surface exposures of phyllite are seen in the area except in the higher parts of the mountain above the village and in some parts around the spring. The area is dominated by sediments that contain boulders of phyllite and other rock types. The size of the sediments varies up to clay size particles. There is also a small escarpment seen upstream of the spring. Thus the spring is of a *depression* type. The present discharge in the spring is about 6 lpm, but this increased discharge is due to the immediate effect of rains on the previous day. This is also indicated by the water quality of the spring water. The TDS in the water are very low indicating it to be water that has travelled a very short distance in the rocks and has had a small resident time in the rock. The entire surface catchment upstream of the spring is a good recharge area for the spring.
