## Short report on Rapid Hydrogeological observations of Springs and Lakes in parts of Sikkim State

Devdutt Upasani

Advanced Center for Water Resources Development and Management (ACWADAM), Pune

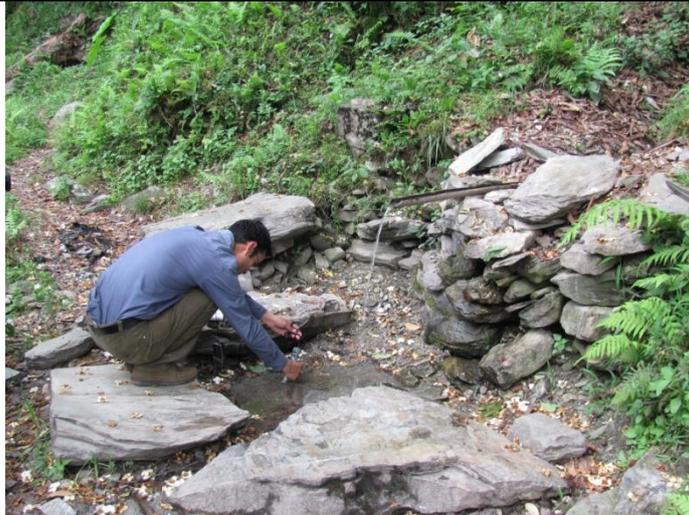
**Sasbote Dhara:** Mainly a *depression* spring as it is surrounded by sediments around it and the spring is formed at a change in the slope gradient of the ground. The discharge of water is about 2.5 lpm. The rock type below the sediments is augen gneiss. The discharge in the spring shows quick response to the rains, which indicates it to be a quick and local system and the water discharged from the spring has travelled a short distance in the ground before getting discharged.

Photo 1: Tracer being used for water quality testing at Sasbote dhara

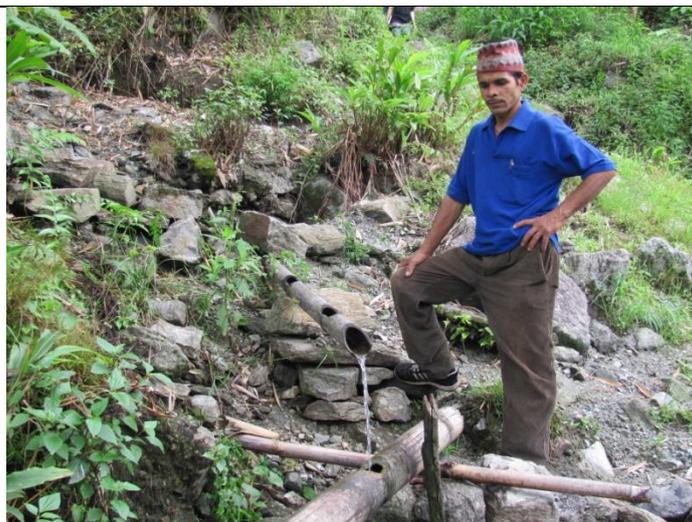
Photo 2: Manahang dhara located along a fracture zone.

**Dal Dhara and Manahang Dhara:** These two springs are also *fracture* springs located along fractures trending in N-S direction. There are many more springs in this area, all located in zones trending

along this N-S direction. These are all fracture springs located along parallel set of fractures trending in a direction of 0°-180°. The water quality measurements indicate water to be travelling from a considerable distance along these fractures but at fairly high transmission rates.

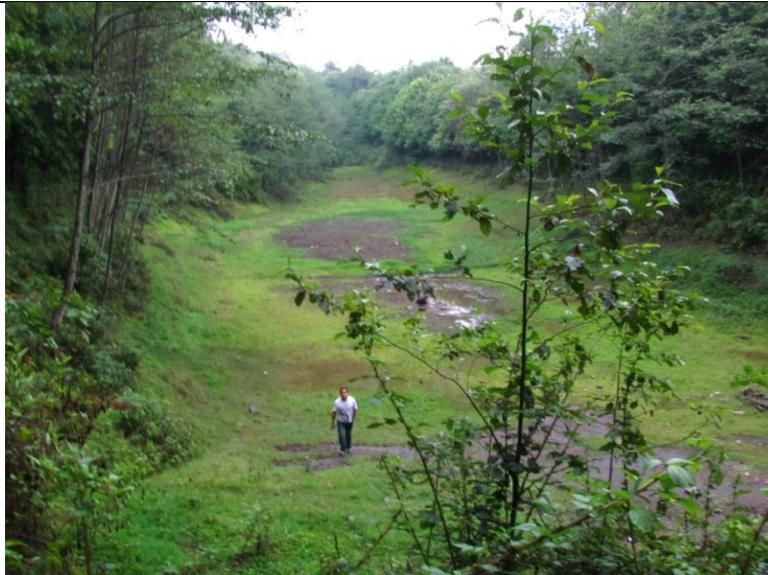
**Poison Lake:** The dried up lake in Kaluk area was studied to ascertain the contribution of groundwater to the lake. It was observed that the reduced inflows in the lake have led to a drying up of the lake. The masonry work done in the lake near the outlet has led to reduced groundwater flow to the lake as it has obstructed the main eastward flow of groundwater to the lake. Also, reduced discharges from a spring located towards the upstream part of the lake have contributed to the drying up of the lake. Recharge activities in the western direction of the lake on the escarpment slope and the top flat portion of the hill will prove significant in increasing spring discharge and

Photo 3: Dried bed of poison lake

baseflows to the lake. Puncturing of the masonry portion can also be considered as a possible intervention for the lake.
